Innovative Solutions for Slope Stability Reinforcement and Characterization: Vol. II

Final Report December 2005

the Iowa Highway Research Board
(IHRB Project TR-489)

6. Performing Organization Code	
7. Authors Hong Yang, David J. White, and Vernon R. Schaefer		8. Performing Organization Report No. CTRE Project 03-127

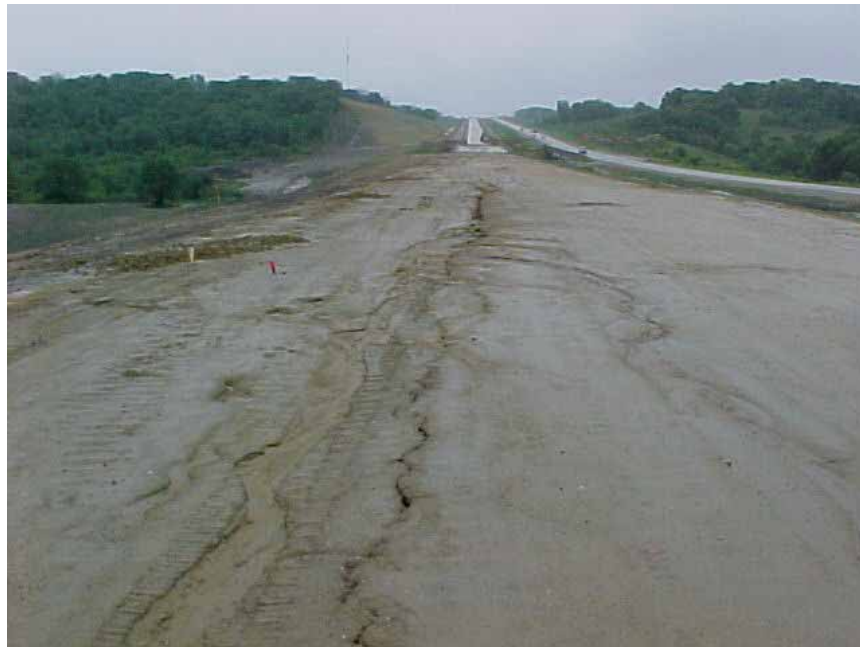
Figure 1. Existing slope failure at Highway 330 in Jasper County, Iowa (White 2003)

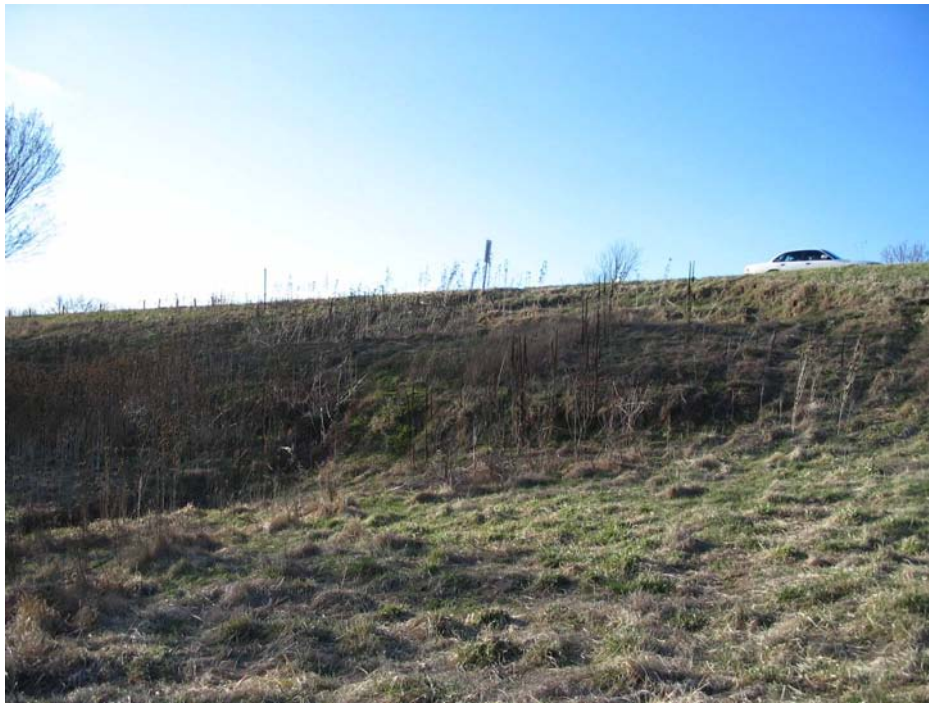
(b) Looking northwest, close view of the bulge and the scrap (photo taken by Yang, 04/01/05)

BST was used to investigate the slope and the shear strength parameter values were used for the slope analysis. The slope most likely failed with a circular slip surface passing the observed scarp. The relatively weak top layer has an average peak shear strength values of $\phi' = 20^\circ$ and $c' = 21$ kPa as measured by BST. It has a softened (mobilized) shear strength values of $\phi' = 12^\circ$ and $c' = 2$ kPa during the slide mobilization; and a residual shear strength of $\phi_r' = 10.5^\circ$ and $c_r' = 1.0$ kPa.

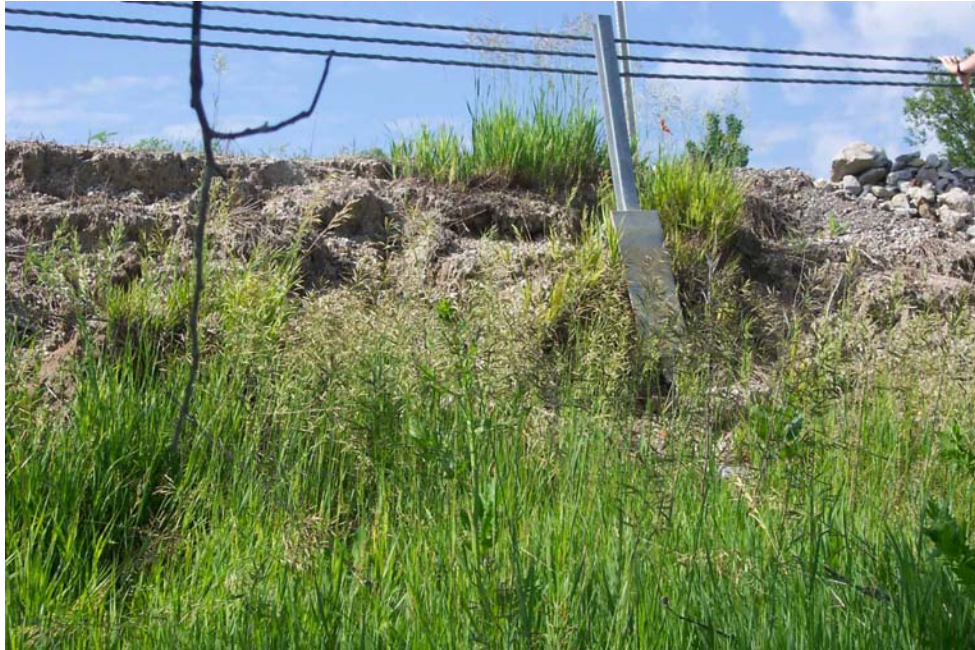
(a) Looking south, showing the scarp of the slope (photo taken by Thompson, 06/04/04)

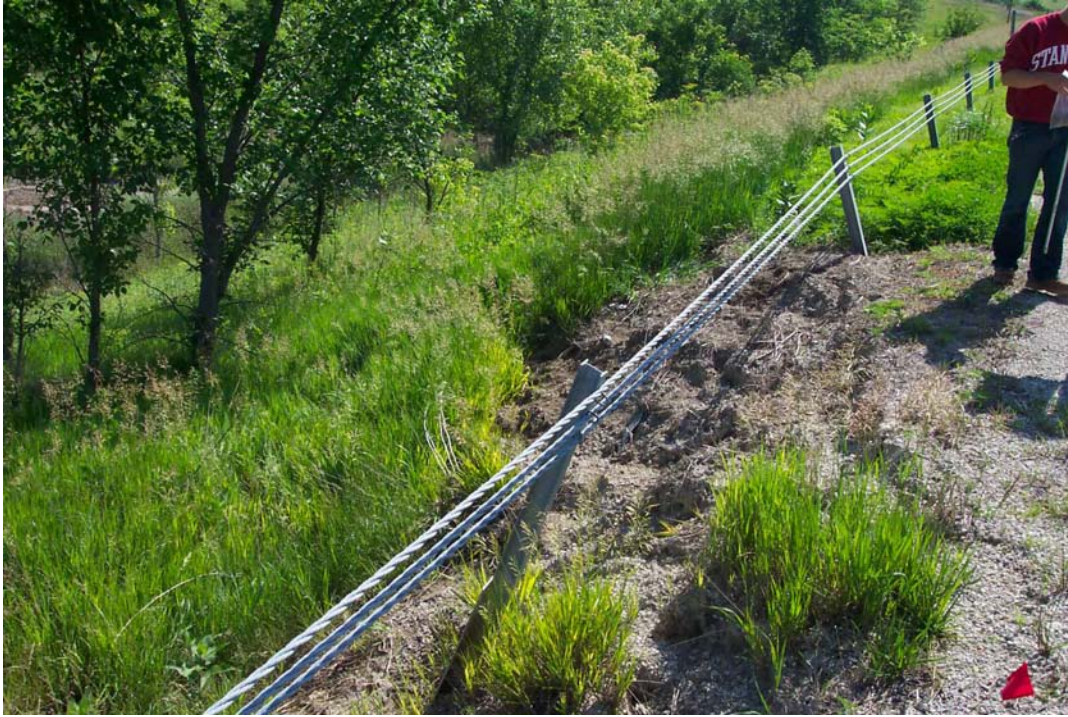
(a) Looking northeast, showing the slope failure at top (photo taken by Thompson, 06/04/04)

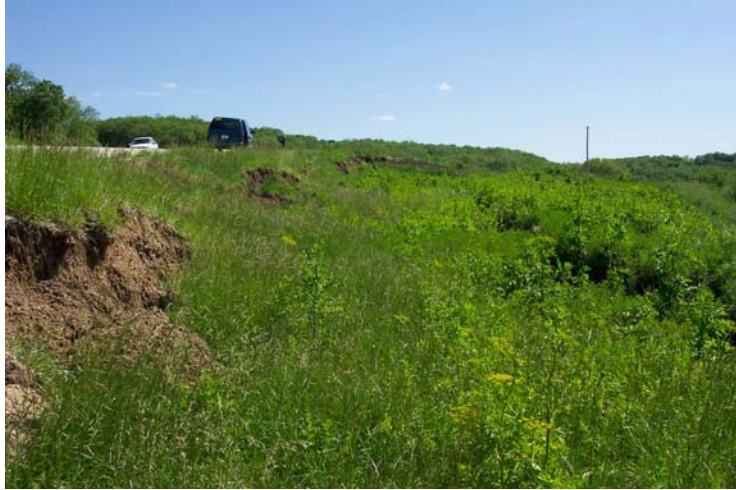
(a) Looking south, showing the scarp and graben of the slope (photo taken by Thompson, 05/26/04)

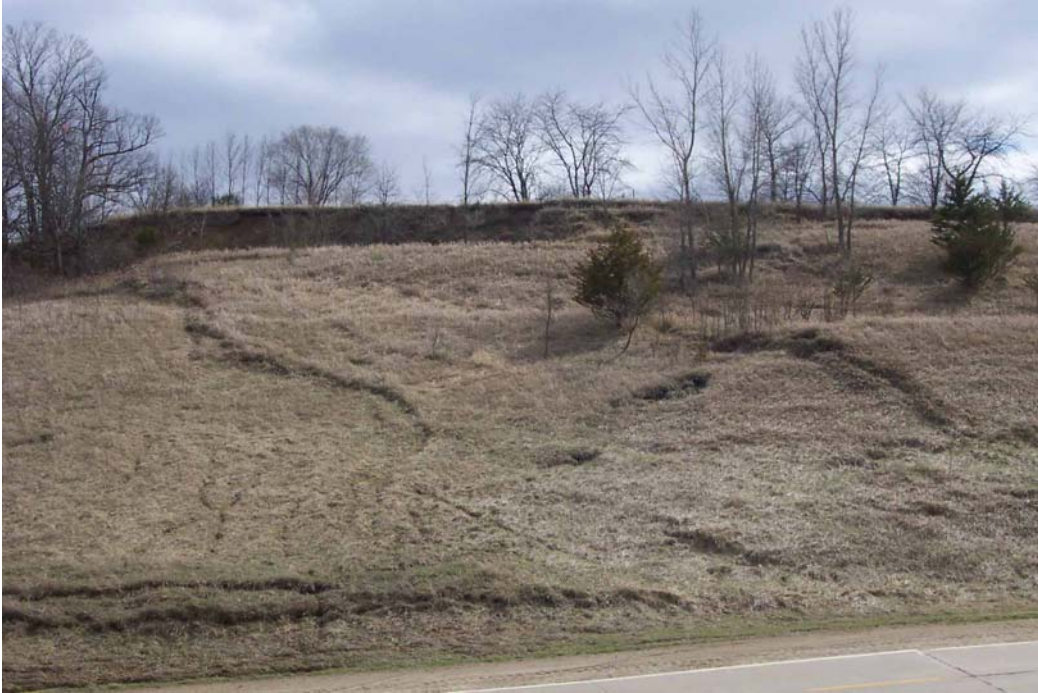
(d) Looking southwest, scarps of the slope 11 (photo taken by Thompson, 03/30/04)
